Example of a Successful Application Severe Abrasion Protection - Power Station

Heavy Duty Abrasion SOLUTIONS with Thistlebond TR240 HD Protection

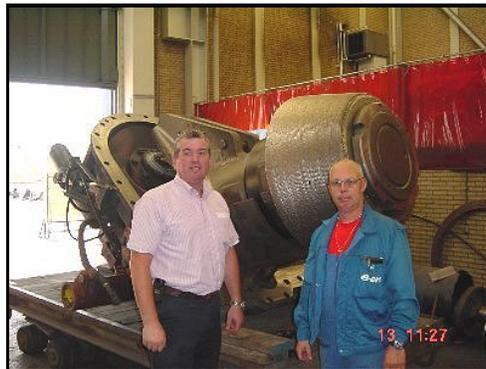
This is the ROTATING UNIT that crushes the coal.

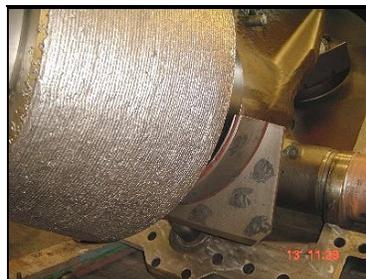
Close-up view of rotating pulveriser.

Further problems occur when the METAL CASE is worn.

If you look to the LOWER RIGHT CENTRE of the photograph above, some **THISTLEBOND TR105** repairs can be seen in 4 areas of the metal. These repairs are more clearly visible in the smaller photograph below.

THISTLEBOND TR105 (Metal Engineering Paste) is used to QUICKLY and EFFECTIVELY seal the holes and enable continued operation.

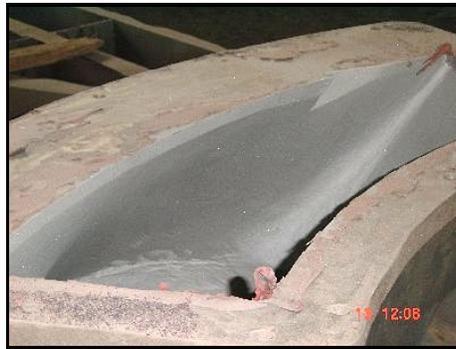
This photograph shows the INLET PIPE CONNECTION as BLASTED

All parts that have been eroded by the coal dust are taken out of service and then BLASTED with GRIT to achieve the required PROFILE (75 microns) for the application of **Thistlebond Heavy Duty Ceramic Wearing Compound TR240**.

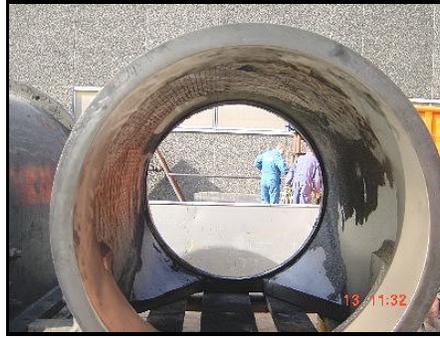
This photograph shows the **DAMAGED INTERIOR**

The **THISTLEBOND TR240** can be EASILY built up to Re-Profile all parts. Once the repair has been achieved a further two coats of **Thistlebond TR205 (Fluid Ceramic - High Abrasion Resistance)** is applied over the surface of the **TR240**.

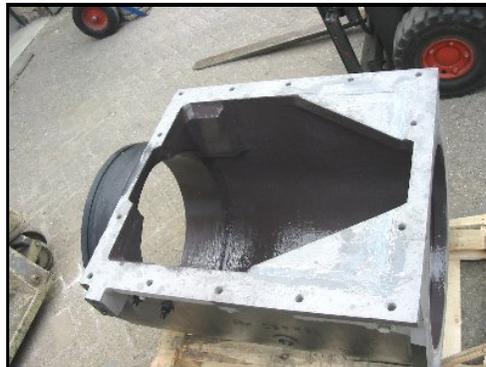
The two photographs above show the FINISHED coating - **TR240 Heavy Duty Ceramic - PLUS - Top Coat of Two Coats TR2005**
