Example of a Successful Application

Repairing an Impeller

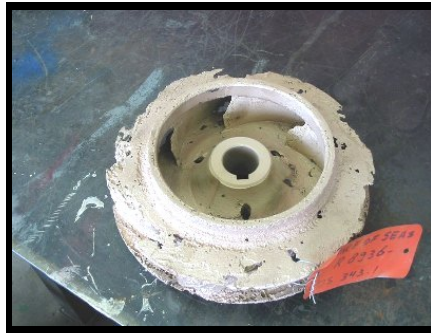
This impeller arrived in our Dutch Distributors workshop from a MAJOR shipping company. It was on-board a tanker and required IMMEDIATE attention. You can see from the EXCESSIVE damage that a MAJOR repair would have to be undertaken OR the impeller replaced. The impeller was made from BRONZE and damage had been caused by SERIOUS cavitation.

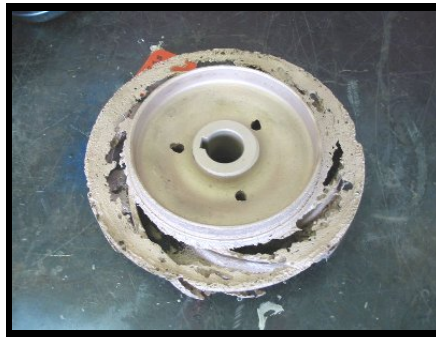
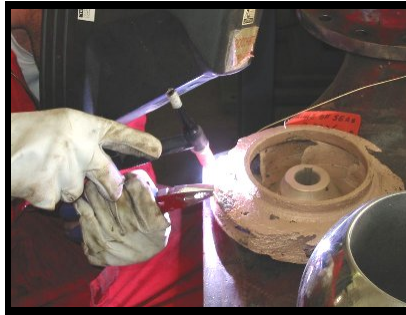
After abrasive blasting the FULL extent of the damage c

an be clearly seen!
