Example of a Successful Application  
Thistlebond saves Oil Company £500,000!

**HEADLINE!**  
**UK Thistlebond Distributor Saves International Oil  
Company  
over £500,000 by using Thistlebond Polymers!!**

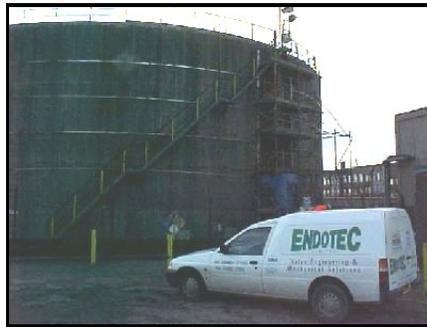
A leak developed in one of the tanks, but it could not be seen where the leak was due to the outside lagging of the tank.

To try to find the leaking area the lagging was taken off and about 3/4 way up the side of the tank a hole was discovered roughly 6mm in diameter, with further perforations.

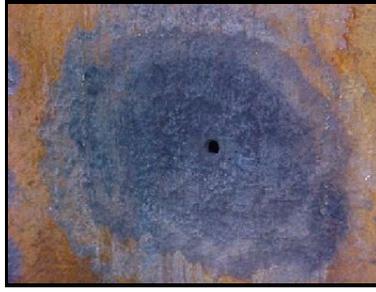
After the damaged area had been identified, 15000 gallons of crude oil was removed by tanker to allow the level of the crude oil to be brought to 2 feet below the leaking holes.

The area around the hole was then prepared - using hand held grinders - to roughen the surface to a minimum sa2-1/2 (75 micron) surface finish.

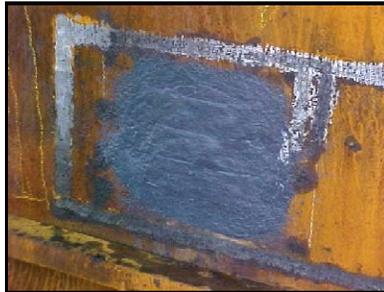
After initial curing a further layer of [TRK19060](#) was put on top of the repair and [Thistlebond TBRT Reinforcement Tape](#) was pressed into the still soft Metal Repair to add a degree of rigidity to the repair.

After which the tank was re-filled and then a steel plate measuring 1.5m X 1m was welded over the TRK19060 repair.

It is important to point out that the TRK19060 HELD UP AGAINST the pressure of the oil contained in the tank at this stage to allow the welding to take place in a DRY atmosphere.
