## Example of a Successful Application Internal Pipe Protection - Sales Opportunities

A recent successful application as carried out by a European based distributor for Thistlebond products shows exactly what can be achieved.

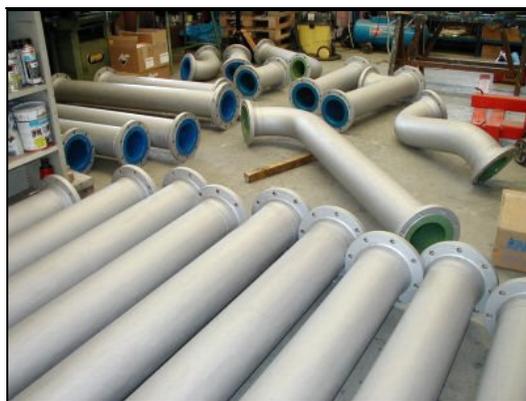
The pipes are 2 meters in length and have a 200mm internal bore.

The application of **Thistlebond TR240 Heavy Duty Ceramic** on all the internal pipe work. Thistlebond **TR240** is the most acceptable product on the market today for protection against extreme abrasion. It is totally "**user friendly**" and offers ease of application and use.

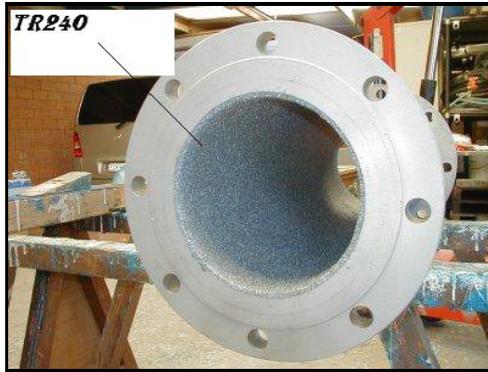
All pipe were first "grit blasted" to 75micron surface roughness (sa2-1/2). Pipes were then solvent wiped and the **Thistlebond TR240** was then applied using techniques developed by the distributor.

On average the coating was 5mm thick and Fluid Ceramic was then applied to the overall surface finish and onto the pipe joint faces.

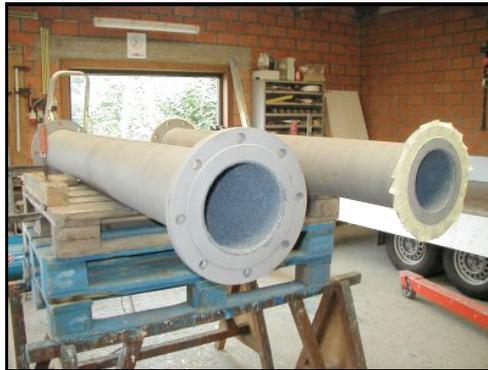
A total of 40 X 5 Kilos of TR240 was used on this application and the end user was extremely pleased with the results that will make major financial savings for the company. Further application work is now being negotiated by our distributor
