Example of a Successful Application Ram / Rod Repair - Waterproofing Joints

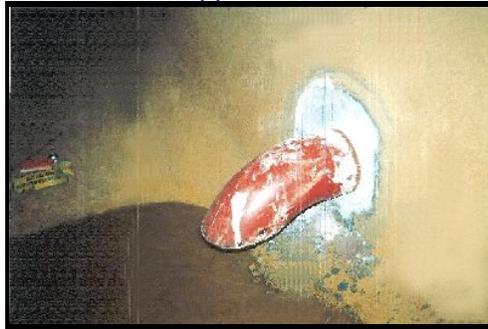
After the PWW had cured(10 days) - 2 layers TR 300 were applied onto the wall and pipe with reinforcement tape between layers.

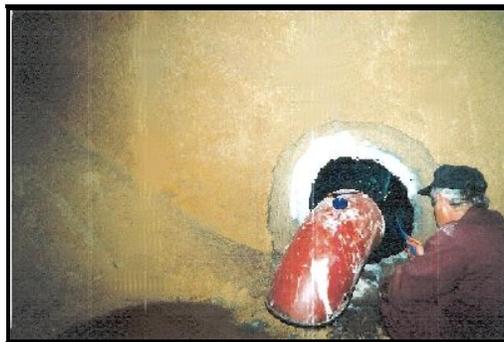
The above method provides an opportunity for application onto a wet surface (PWW) and also ensures flexibility in the joint between concrete wall and metal pipe. Any vibration, shocking or thermal cycling is therefore dealt with WITHOUT breaking the integrity of the seal obtained by using THISTLEBOND and ADVANCED POLYMER products between the wall and pipe outside diameter.

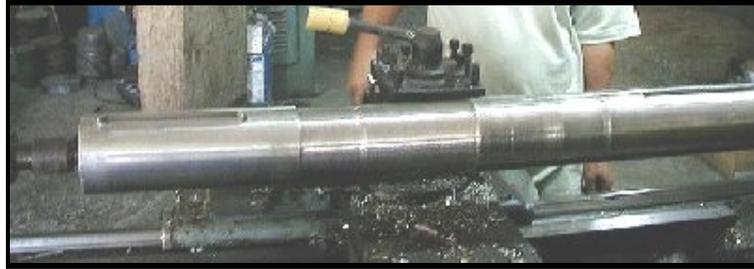
The photograph below shows a large STAINLESS STEEL RAM.

The shaft is in a lathe where the badly worn area has been undercut to a MINIMUM of 6mm (3/8") to enable enough Thistlebond TR105 to be mixed and applied to the area. Please note that the EDGE of the SHAFT on both sides where the Metal Repair is being carried out are at a 45% angle. This is an IMPORTANT part of repairing metal shafts.

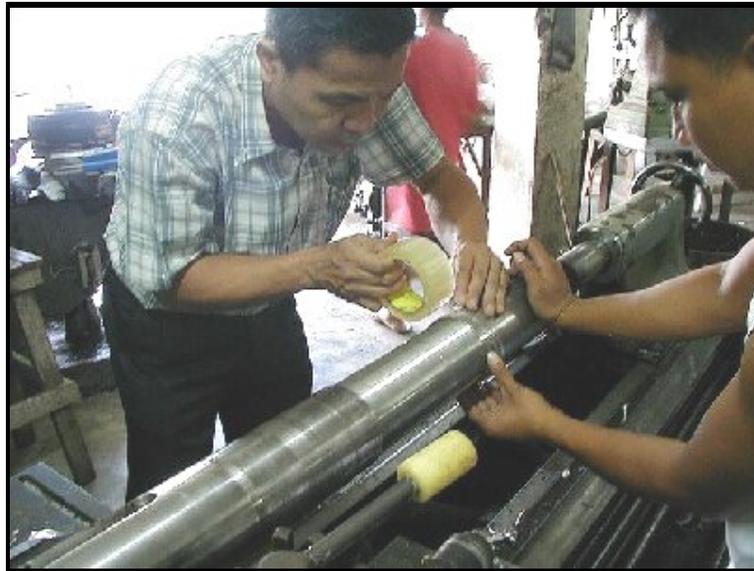
The edges are being taped to prepare for the coating to be carried out.

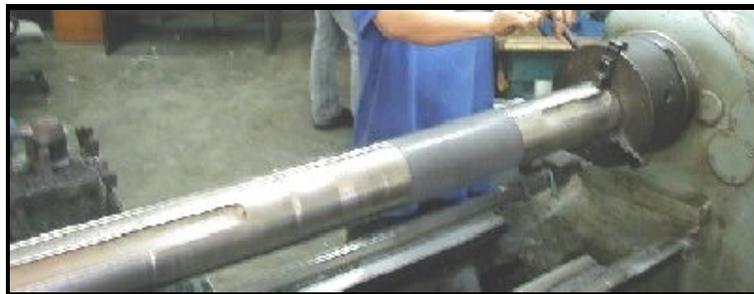
The shaft has now been prepared and the lathe used to cut down excess metal repair product and produce a uniform outside dimension.

Thistlebond will hold tolerances as required by the most exacting criteria. Thistlebond also resist attempts to vary in dimensional size even after full curing has taken place.

Machining can occur in the 'green' stage of curing. That is to say, after the INITIAL cure an end-user can machine and then wait for a FULL cure prior to using the equipment.
